OPERATION AVERT 1

Operation Avert

A Divisional Road Policing Initiative

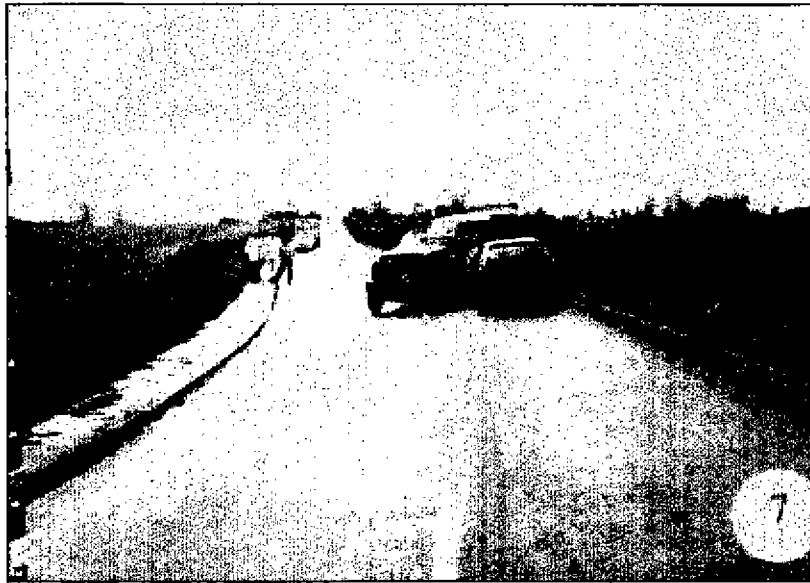
On the approach to the bend there is clearly poor signage, as a result this section of road is subject to an inordinately high number of serious/ fatal road traffic accidents, which cause distress to victims, relatives, friends and can cost the emergency services time and
