Reducing Road Deaths and Serious Injuries

Operation NESO

Location: A12, North East London, United Kingdom

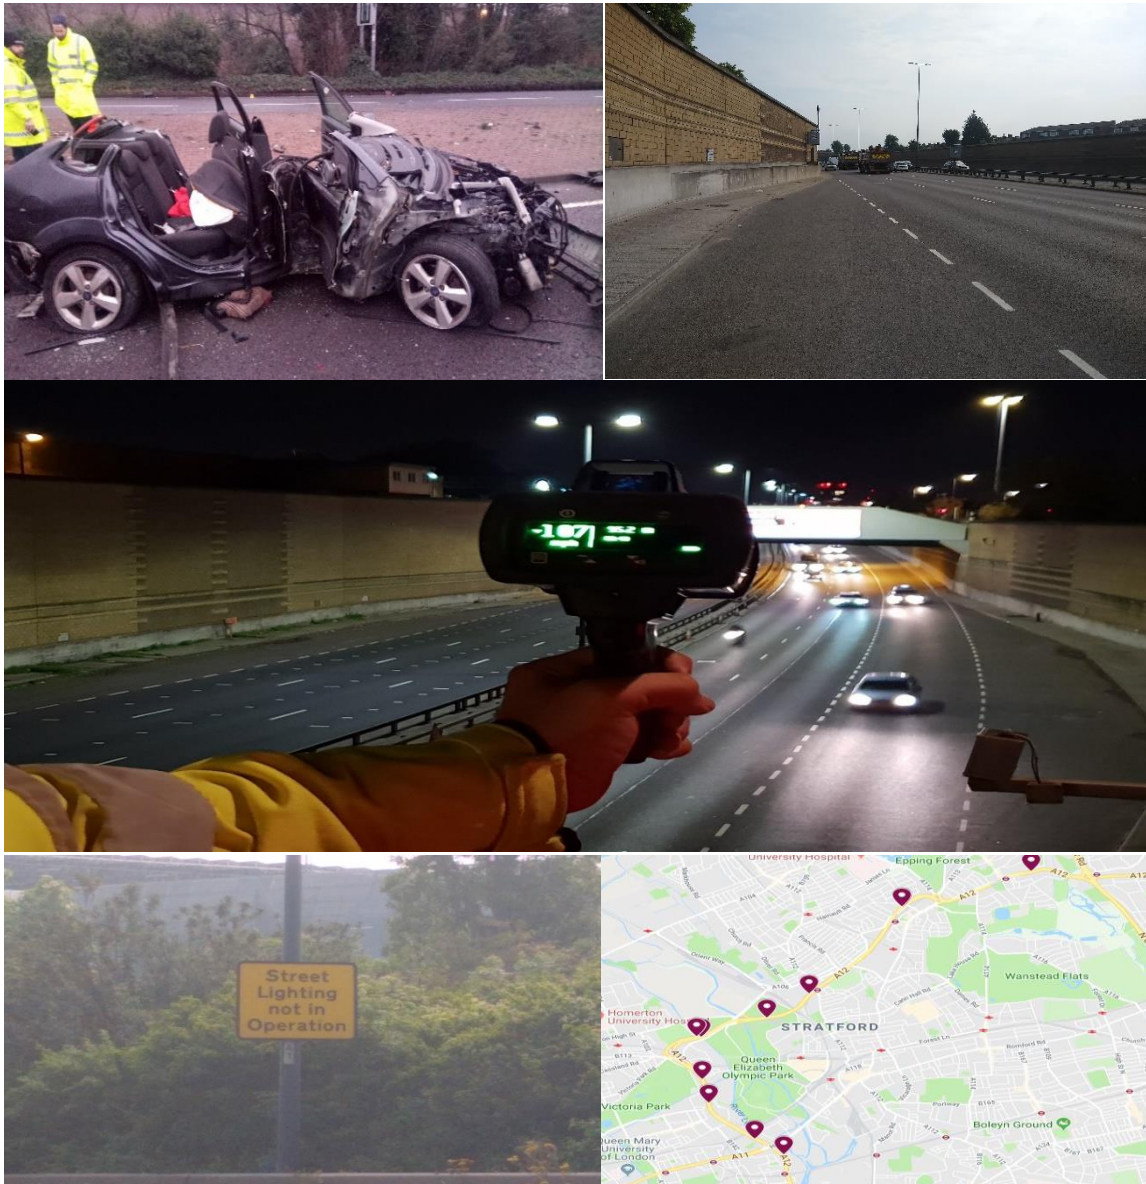
Cover images left to right from top:

1. Vehicle involved in serious injury collision, January 2018
2. High walls lining the road
3. Pro-Laser speedgun reading of a vehicle in a 50mph limit, January 25th 2019
4. Streetlighting information sign
5. Map showing former speed camera locations

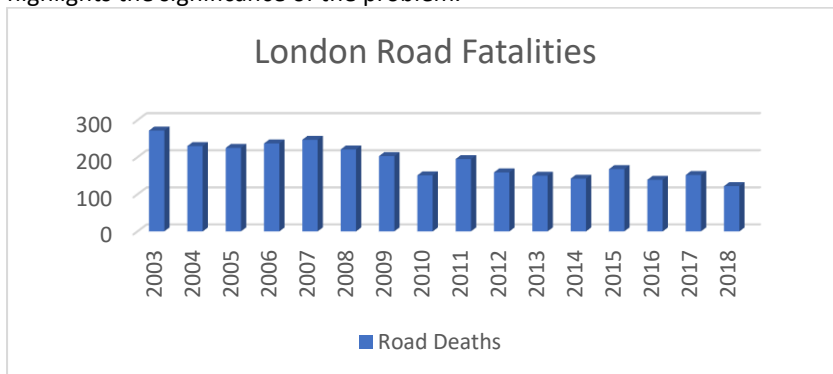
³ In the period from 2003-2018 road fatalities have significantly reduced across London as shown on this graph. The 3 previous deaths on the A12 occurred in 2003 (1) where there were 272 fatalities across London and in 2008 (2) when there were 221. For 5 to happen when there was an all-time low of 122 in total in London highlights the significance of the problem.

Reliable statistics in relation to fatalities on this road only go back to 2003. These show that between 2003 and 2018 there were 3 fatalities with the last one occurring in August 2008. Between April 2018 and January 1st 2019 there were 5 fatalities. Added to these there were 3 further collisions involving serious injury in 2018. In 2017 there were just 3 serious injury collisions on this stretch of road (no fatalities) making the 2018 total Killed or Seriously Injured (KSI) figures a 266% increase year on year. In the same period, across London, road traffic fatalities dropped from 152 in 2017 to 122 in 2018 a decrease of 19.7%.³

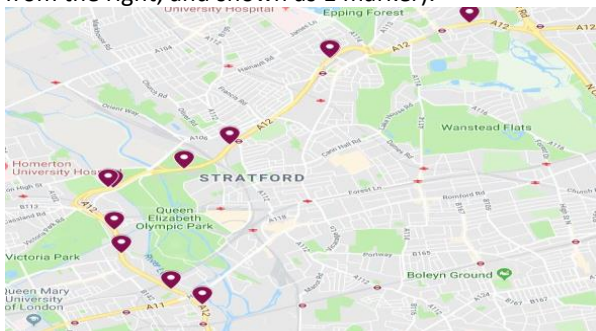
⁴ The sites of the 11 cameras that were removed (2 are in the same place on opposite carriageways, second from the right, and shown as 1 marker).

limit is 70mph¹. To prevent this, several sites for static speed enforcement cameras were identified and in total 11 cameras were placed along the 6 mile stretch of road. This caused some negative press attention as they were reasonably new and unpopular with the public. The general rule governing the siting of them was that they were put into collision hotspots where it could be shown that speed was a factor². As the road was brand new how could the cameras be justified? The Police and LRT successfully argued their case and the cameras were put in.

A closer look at the infrastructure showed that over time the 11, fixed site, speed cameras had not been maintained nor replaced during the upgrade from wet film to digital. 6 were removed and 5 were no longer operational. They were removed due to their efficacy as the criteria for installing or upgrading the cameras relied on evidence the road in question was a collision hotspot. For 3 previous fatalities in 15 years how could 11 cameras be justified? With budget cuts, money was spent elsewhere where there was evidence of KSIs.

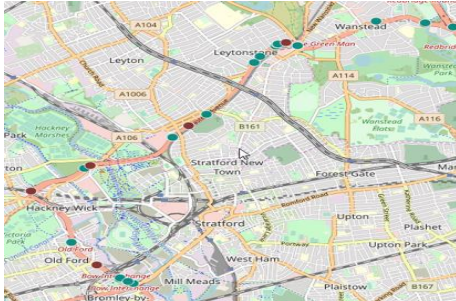
⁹ The sites of the fatal (in red) and serious injury (green) collisions from January 2017 to January 2019. Note the proximity to the speed camera locations above.
